# INSTALLATION RESTORATION PROGRAM PHASE I — RECORDS SEARCH

5073rd Air Base Group Shemya AFB, Alaska

JRB Associates
A Company of Science Applications International Corporation

September 1984

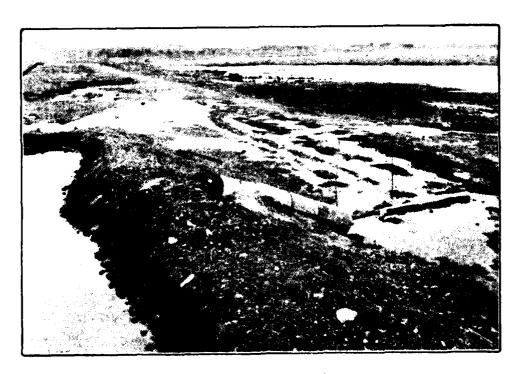
Site PS-3, West End Oil/Water Separator HARM Ranking: No. 7

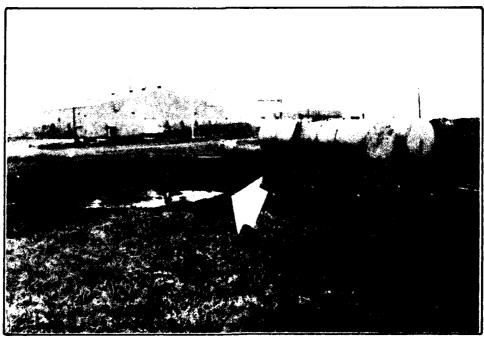
Site PS-5, Power Plant Spills HARM Ranking: No. 1
